TOWN OF MINTO

SUBJECT: Bridge and Culvert Biennial Inspection Report

Re: Bridge N, Brunswick St. Drain, Sub-structure Flood Review

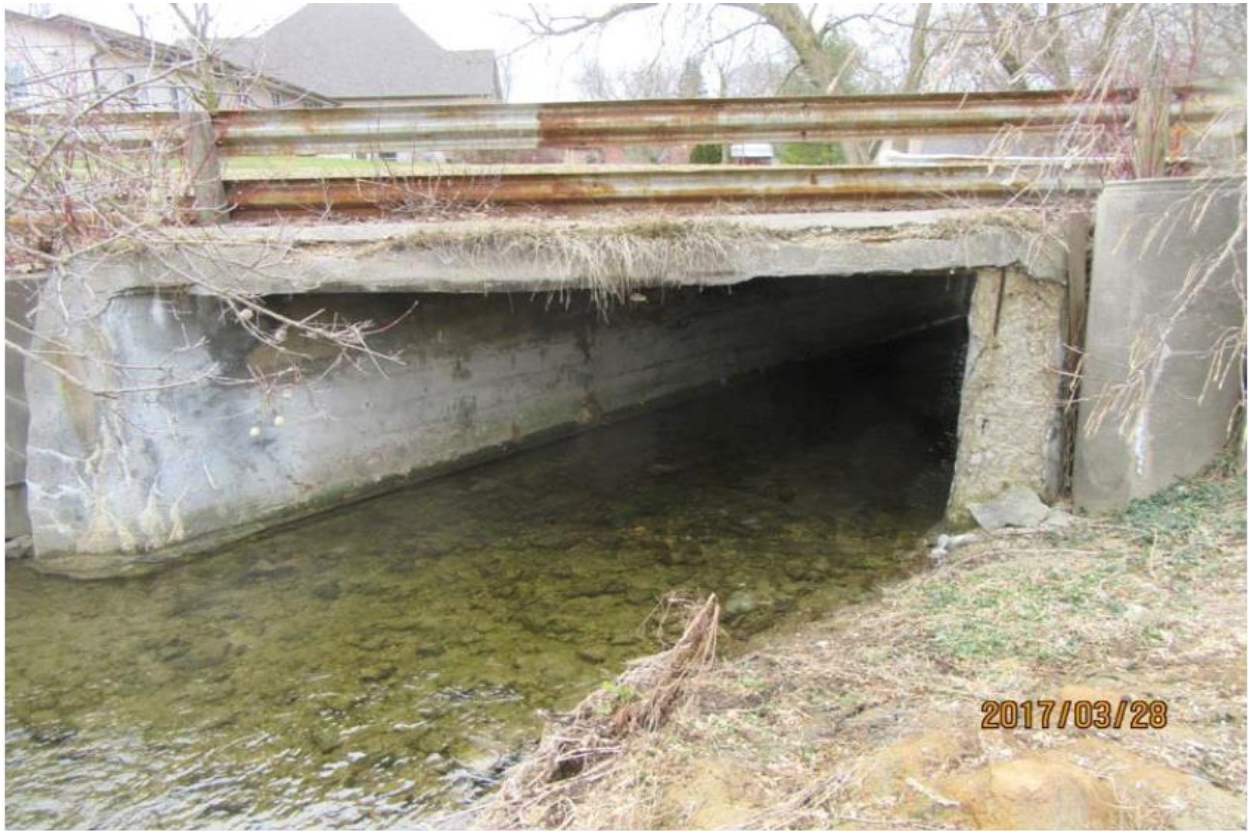
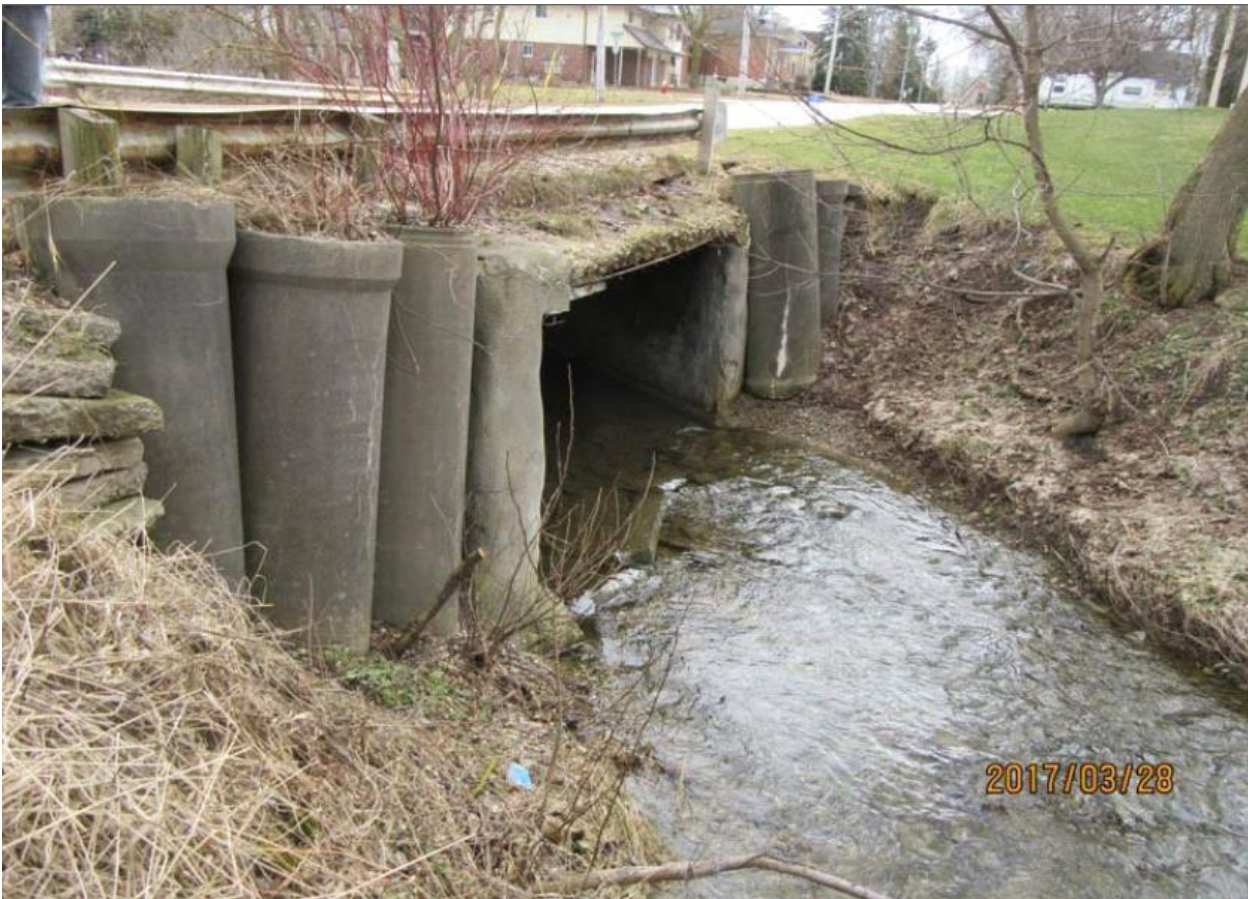
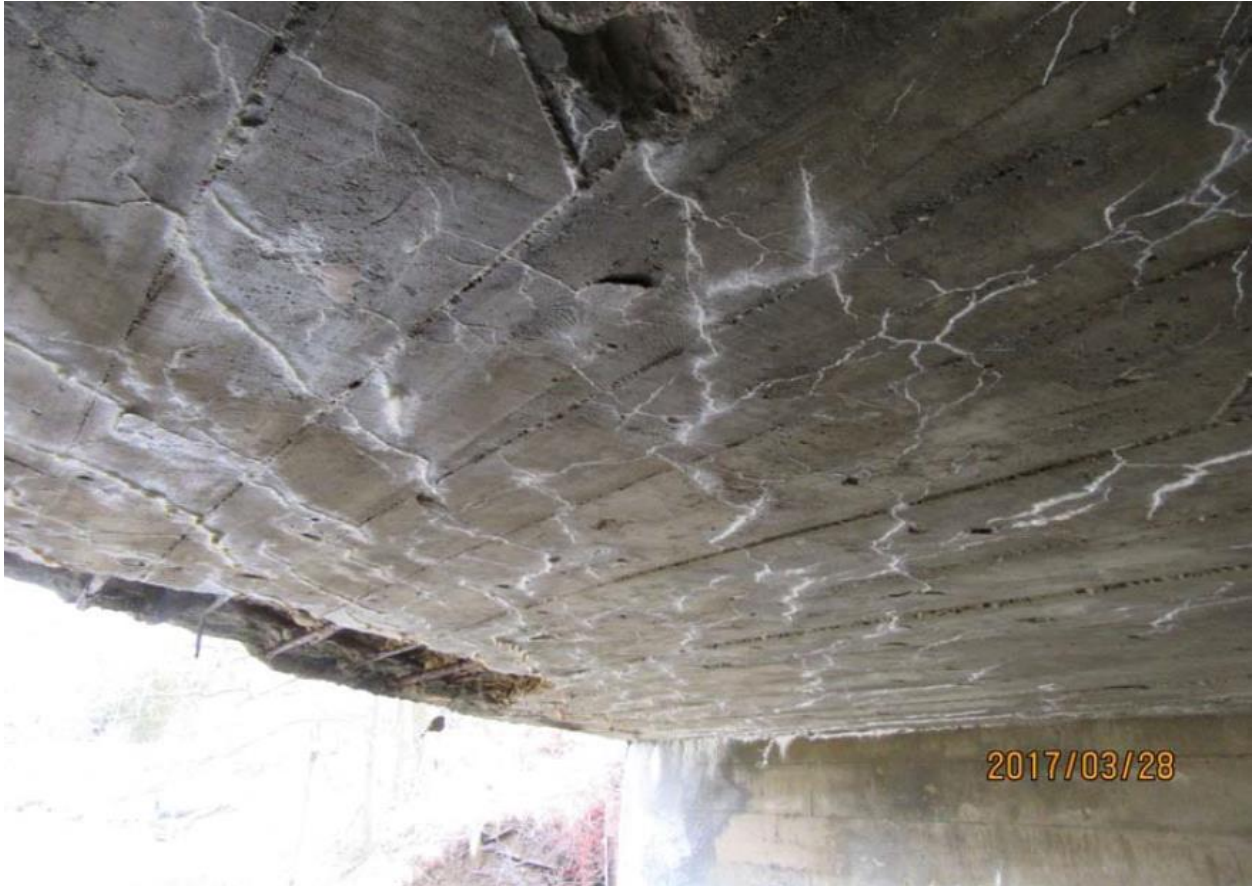
Following February 20 event, staff noticed areas of erosion that might impact the integrity of the structure and embankments on the Brunswick St Culvert in Palmerston. Burgess Engineering was called in to complete a structural inspection on this culvert compared to the 2017 inspection. The attached updated report and recommendation from Burgess Engineering Inc. confirms there is no immediate threat but the structure should be inspected every six months.

This concrete box culvert (non-rigid) is in poor condition. The top slab has advanced concrete deterioration (break-down) at both the inlet and outlet. This deterioration is advancing inward and starting to affect the inner barrel. In addition the walls are rotating inward due to soil pressure and insufficient rigidity of the connection to the top slab.

This structure is exposed to fast water flows. The existing embankment protection is comprised of various concrete sections and is slightly undermined at the inlet.

Currently there is no sign of critical structural distress. However due to the advanced state of deterioration, wall inward movement, and fast water flows, we recommend this culvert be inspected every 6 months until replaced or closed.
