**TOWN OF MINTO**

**DATE:** October 31, 2018  
**REPORT TO:** Mayor and Council  
**FROM:** Mike McIsaac, Roads & Drainage Manager  
**SUBJECT:** Brunswick St Structure N, Palmerston

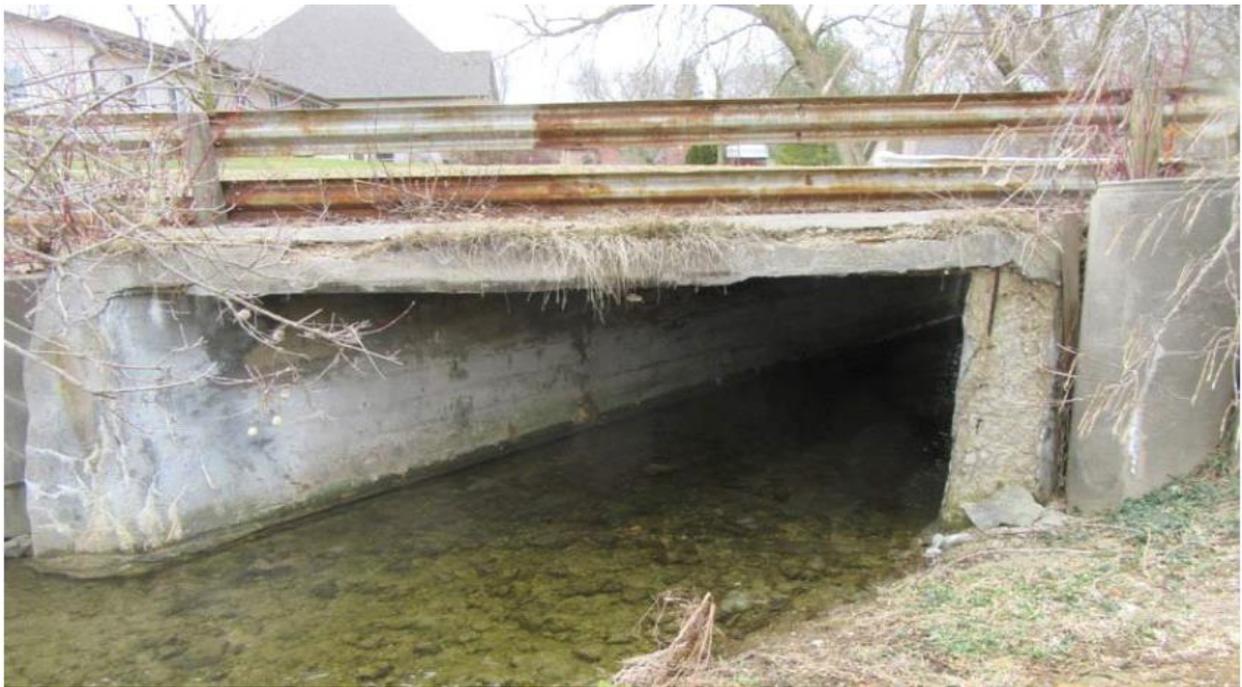
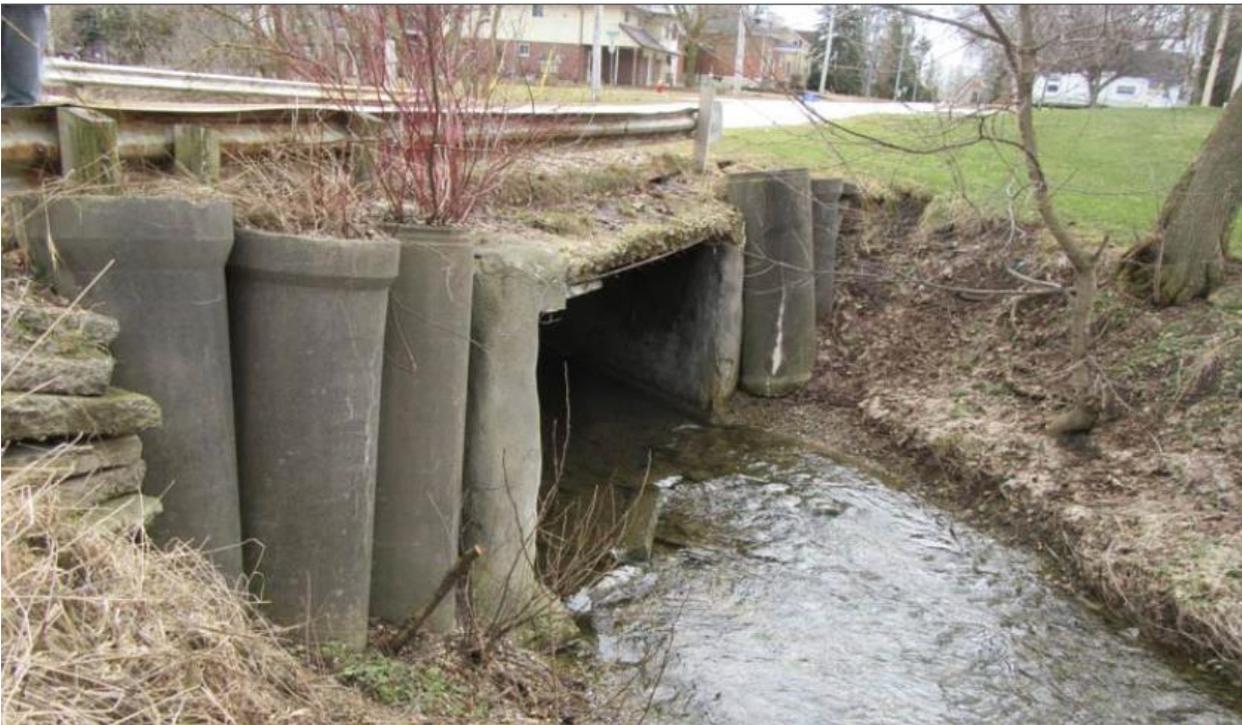
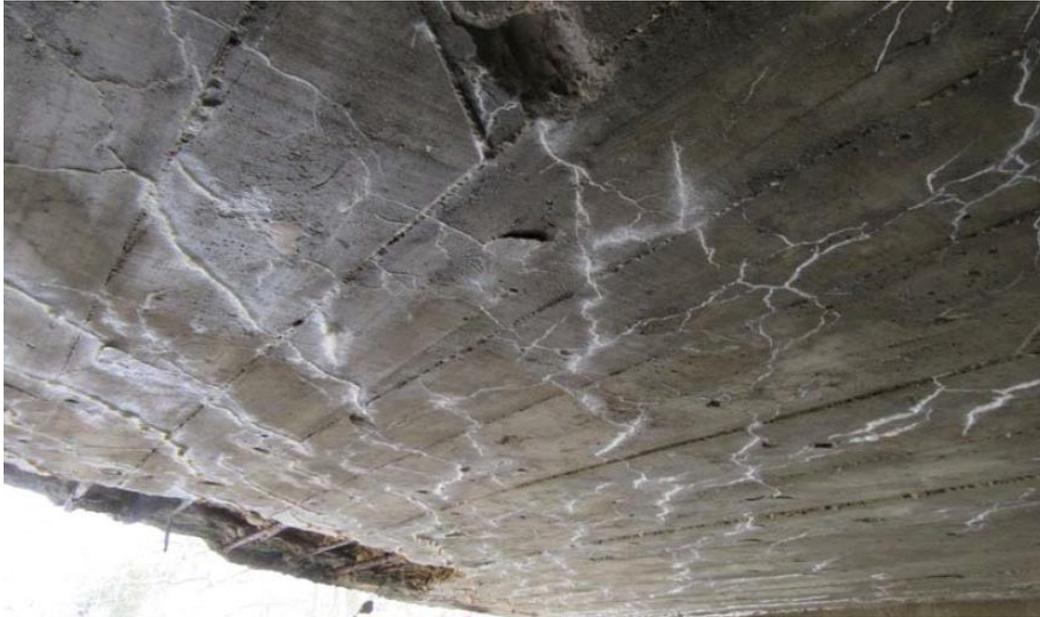
emergency services during this closure. The closure is a minor inconvenience to area residents who have to travel an extra block to go downtown. The bridge is open for pedestrians. The pictures below document its condition in spring 2017.

As previously noted the exterior sections (inlet/outlet) of this culvert have advanced concrete deterioration. Basically the concrete is disintegrating back into gravel. The concern is when this deterioration/breakdown advances into the inner barrel regions. In addition when this process of deterioration is this advanced the further rate of breakdown increases.

This concrete box culvert (non-rigid) is in poor condition. The top slab has advanced concrete deterioration (break-down) at both the inlet and outlet. This deterioration is advancing inward and starting to affect the inner barrel. In addition the walls are rotating inward due to soil pressure and insufficient rigidity of the connection to the top slab.

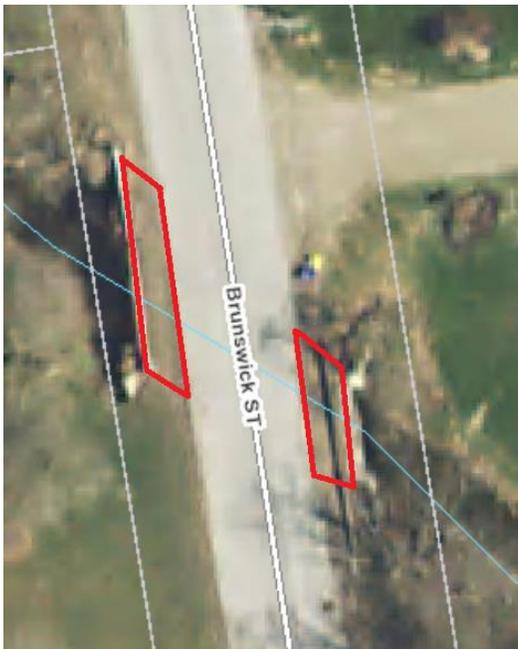
Staff closed Structure N October 31, 2018 upon receiving the recommendation from Burgess Engineering Inc. June 23, 2017 and February 20, 2018 flooding has been hard on this structure. Current approximate limits of deterioration at the headwalls are shown in red.

Based on our recent inspection we noted that further deterioration and propagation of this deterioration has advanced into the inner barrel region. We are at the point where the structural integrity of this culvert is in question and we recommend closure. The existing culvert could be replaced with a pre-cast box or open footing rigid frame if this road is to be opened in the future.

That Council receives the Roads and Drainage Manager's report dated October 31, 2018 Brunswick St Structure N, Palmerston and directs that Structure N, on Brunswick St in Palmerston remain closed until budget for a replacement structure is approved.
