TOWN OF MINTO

DATE: August 15, 2016
REPORT TO: Mayor Bridge and Members of Council
FROM: Mike McIsaac, Roads Foreman
SUBJECT: Structure P Rail Trail Fire

Re: Bridge P - Fire Damage Report

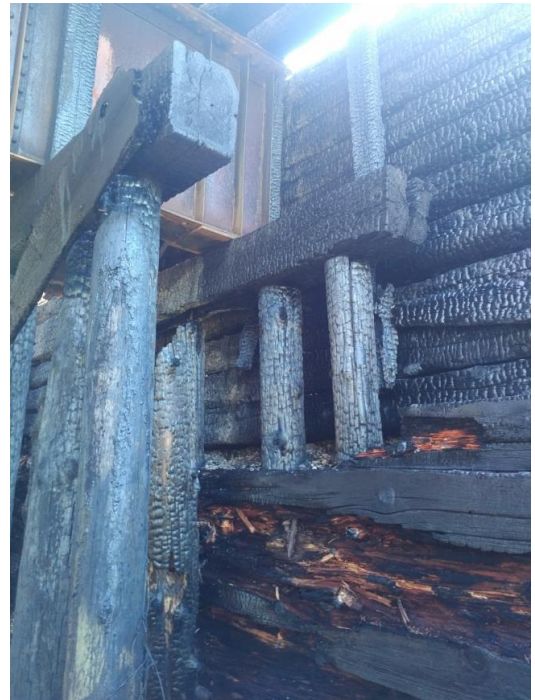
Minto Fire responded to a Rail Trail Bridge fire between the 3rd Line and 5th Line on Saturday, August 6. Damage from the fire left the bridge unpassable and resulted in its immediate closure. August 8 Andrew Burgess of Burgess Engineering Inc visited the site to investigate the structural integrity and submitted the attached preliminary report.

- remove and dispose of the deck members
- excavate the south approach and remove and dispose of the barrier railway system
- remove all surface charred material to expose sound timber on all the substructure members.

Once the above is finished further inspection of the existing structure will confirm how much of the substructure is compromised.

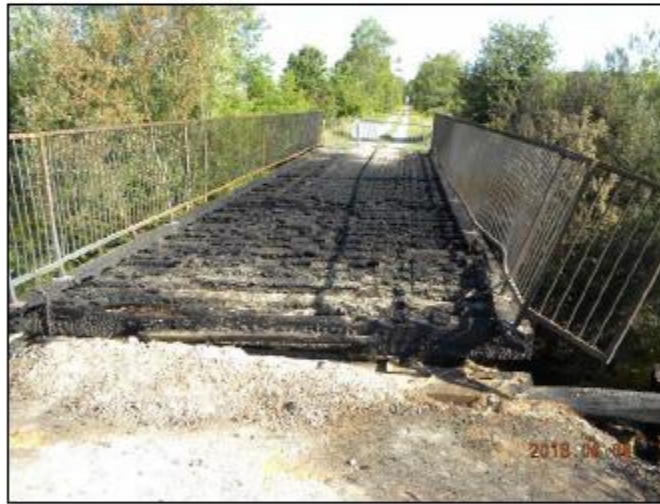
On August 9th, 2016 we conducted a visual inspection of the above captioned pedestrian bridge. The structure was recently damaged in a fire.

- ✓ The deck members (super-structure) have considerable section loss.
- ✓ The fire was concentrated on the south end.

- ✓ Install temporary barrier system across both approaches and post bridge closed.
- ✓ Remove and dispose of the deck members and railing system.
- ✓ Remove all surface chard material to expose sound timber on all the sub-structure members.
- ✓ Complete a follow-up inspection.
