2017 Summary Report

Town of Minto

PALMERSTON DRINKING WATER SYSTEM

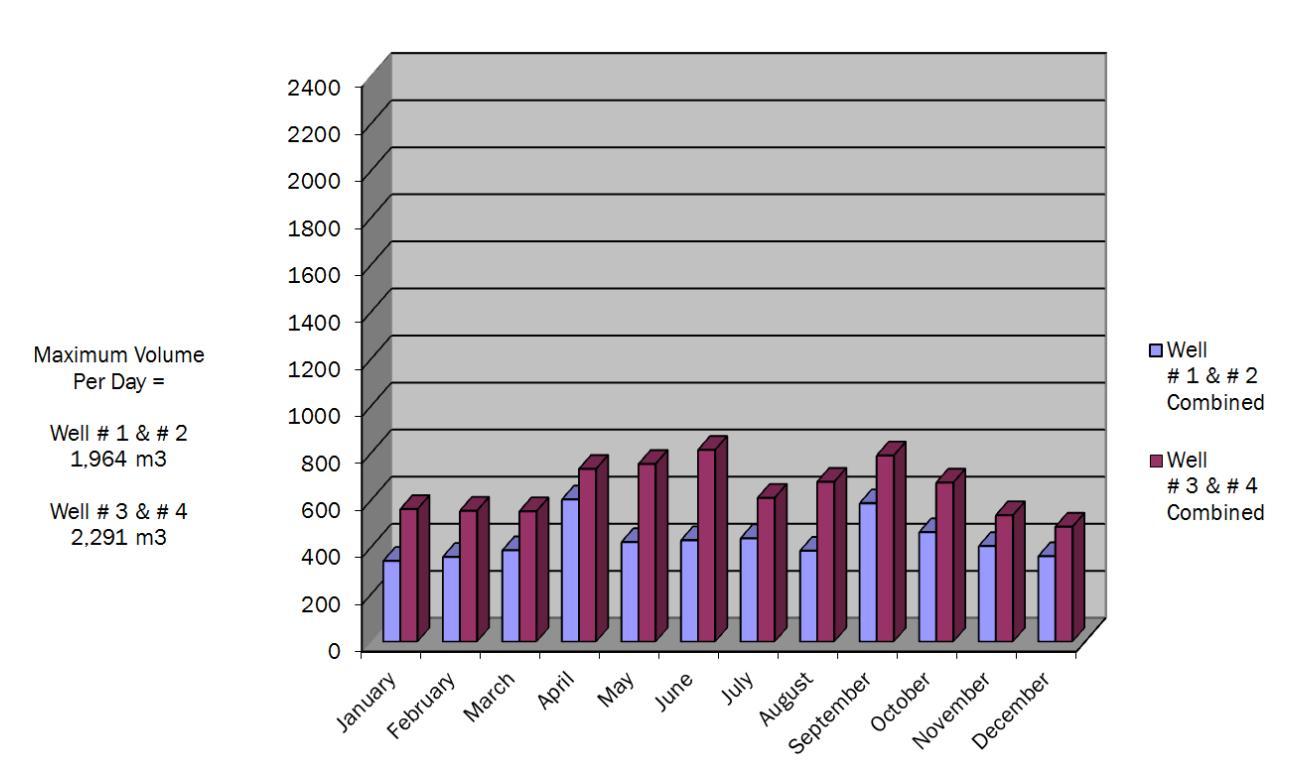
Table 3.8Maximum Water Usage Per Day by Month

The MDWL stipulates, "The maximum daily volume of treated water that flows from the treatment subsystem to the distribution system shall not exceed the value identified as the rated capacity in Schedule C Table 1."

Short-term peaks, in excess of permitted values, may occur at pump start up, while doing specific maintenance procedures or during emergency demand situations. An occurrence of this nature is not considered an exceedance.

The time and duration of any flow exceedance is recorded for each event along with the reason for the occurrence. There were **no exceedances** of the allowable flow rates in the Palmerston Drinking Water System.
